**EVALUATION OF MECHANICAL PROPERTIES,
OXIDATION RESISTANCE, AND STRUCTURE OF
SLURRY SILICIDE COATED T-222**

by
A. M. FILIPPI

Westinghouse Astronuclear Laboratory

**NATIONAL AERONAUTICS AND SPACE ADMINISTRATION
NASA Lewis Research Center
Contract NAS 3-12410**

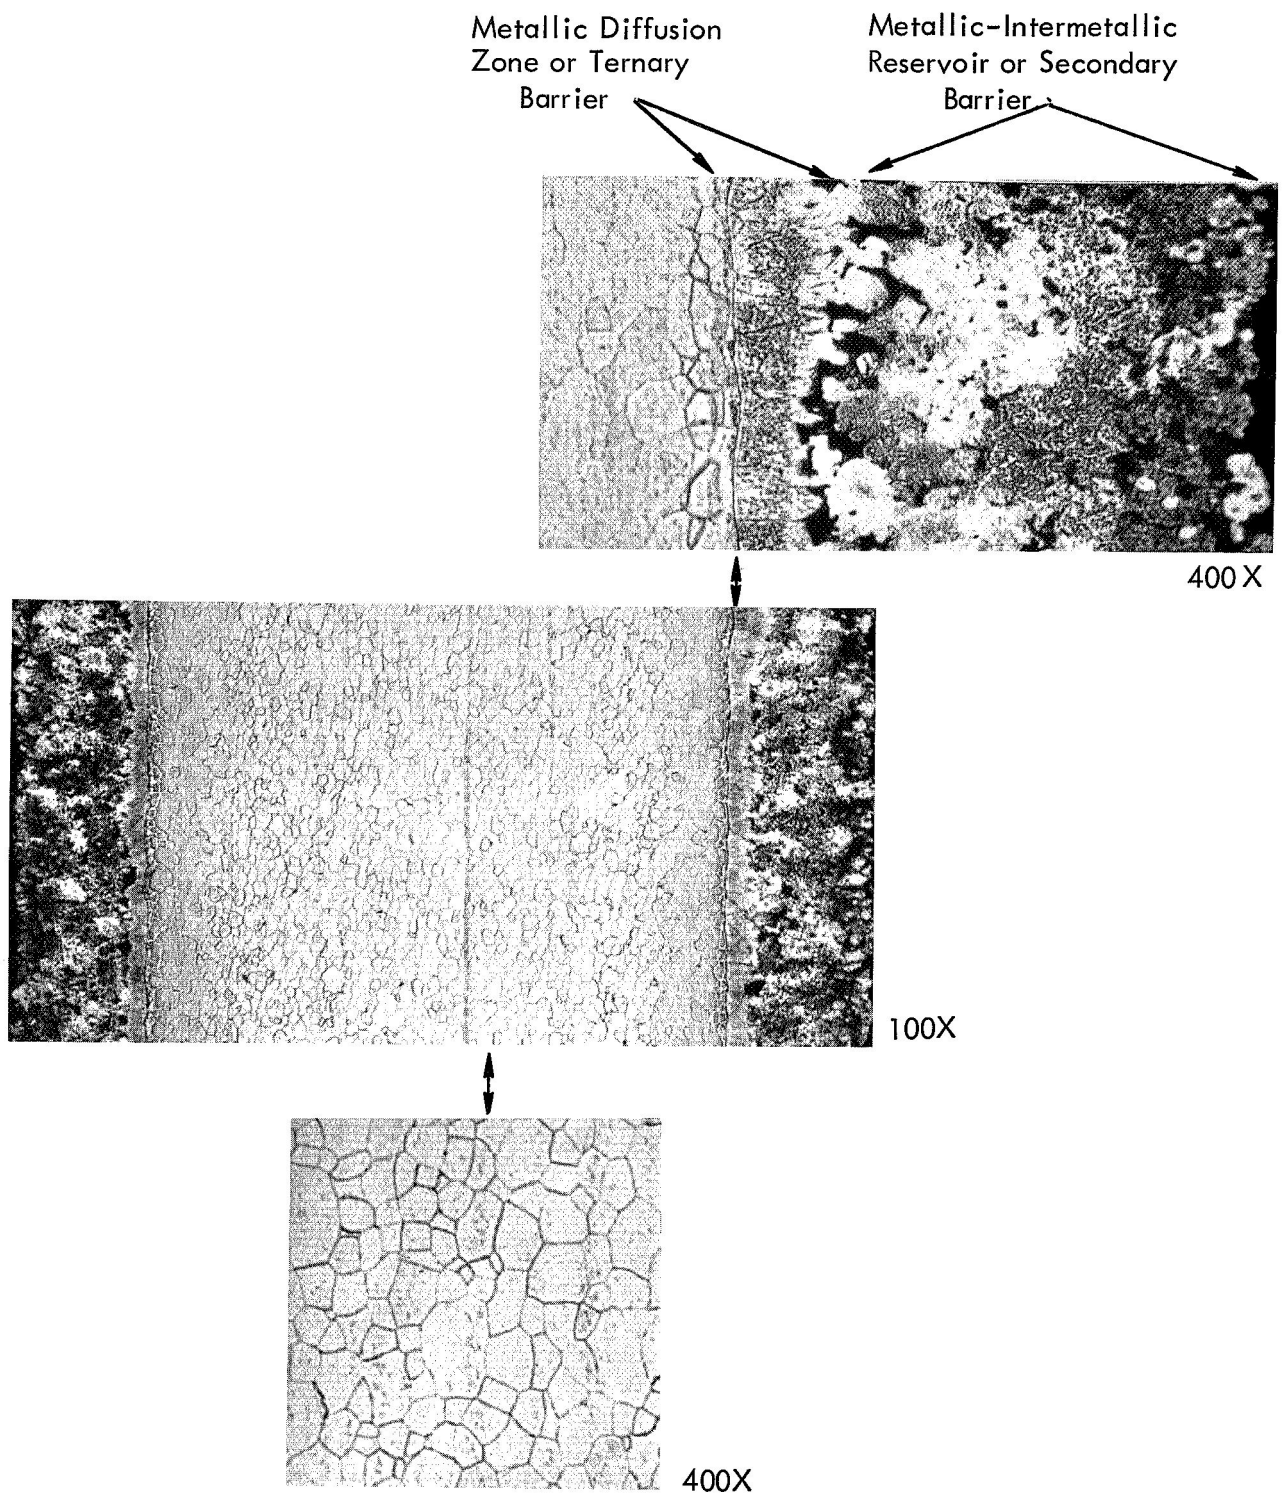
FIGURE 3 - Microstructure of Coating-Substrate Cross Section

These test results definitely show that contamination, to the point where substrate ductility was seriously impaired, did not occur during coating or any oxidation condition examined. The very minor increase in DBTT noted for as-coated, and coated and oxidized material, probably reflects, in part, structural changes induced in the substrate by the treatments. The substrate was in the solution treated, 1 hour/ 3000°F , condition prior to coating. Coating, and all exposure conditions, were performed at temperatures where carbide precipitation would occur in the substrate^(4,5). The presence of precipitates in the substrate can be seen in the photomicrographs of Figure 3 representing the as-coated condition.

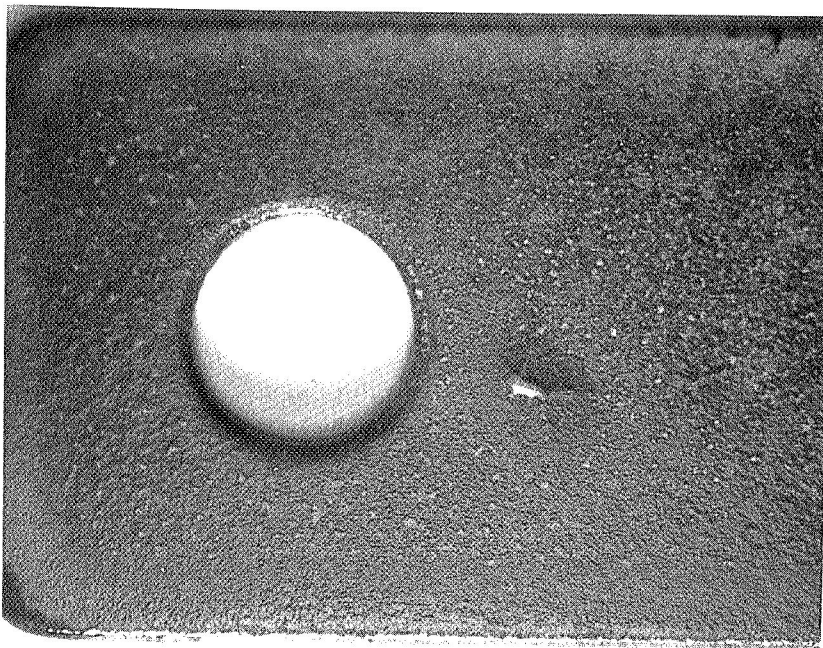
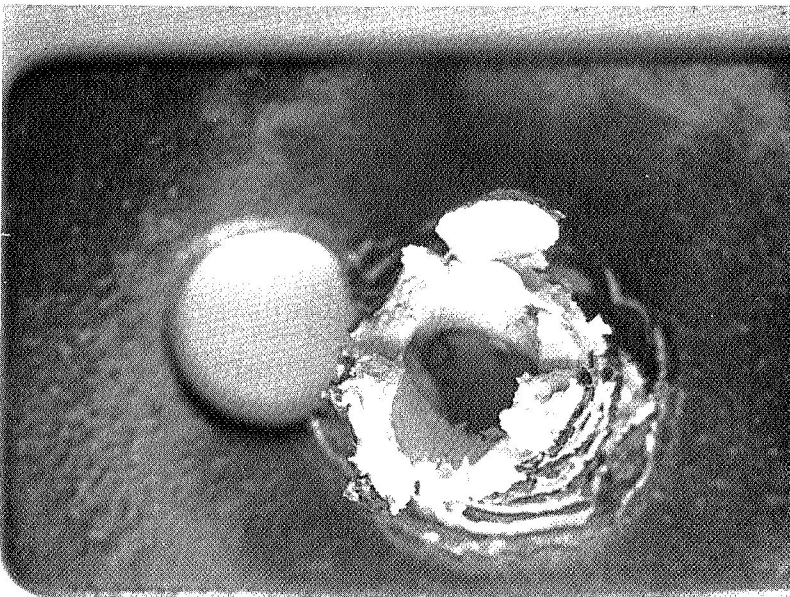
FIGURE 7 - Progress of Coating Failure on Tensile Sample 28

Oxidation behavior at 2400° F was erratic with four of twelve samples surviving 304 hours of testing, the others exhibiting coating failure at times between 21 and 304 hours at temperature. Coating cracks developed on many samples oxidized at 2400° F during the first two hour exposure period, but were observed to fill with oxidation product upon further exposure, forestalling coating failure for some time.

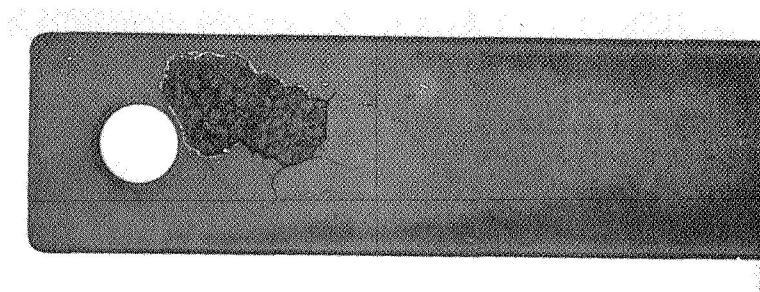
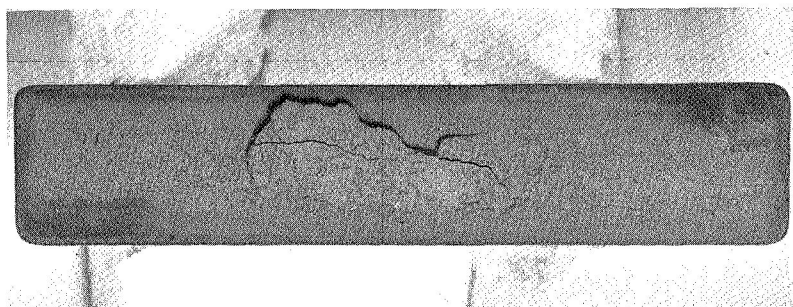
FIGURE 14 - Coating Failures on Samples Oxidized at 1400°F (1033°K)
Top: 2 Hrs/1400°F
Bottom: 2 Hrs/1400°F + Air Cool + 2 Hrs/1400°F

Pronounced coating failure occurred on all four tensile samples during the initial two hour exposure period at 1400° F. Cracking and lifting of the coating over one or several large flat regions within the head sections characterized the failures. Although the general vicinity of coating failure was similar to that noted on several samples exposed at 2400° F, failure at 1400° F developed over much larger areas, and appeared to be progressing rapidly along the coating-substrate interface toward the gauge sections. A photograph displaying one of the smaller coating failure areas on a tensile sample is shown in Figure 14.

The samples were racked on an inconel fixture and supported through the grip pin holes — Figure 5. Because of this, it was thought perhaps expansion of the fixture might have imposed a stress on the samples, inducing coating failure. To examine the possibility, another sample, tensile 23, was placed unrestricted across the inconel support rods with only its weight holding it in place, and exposed for 2 hours at 1400° F. Coating failure, similar to that noted on tensile samples 19 through 22, occurred on this sample. None of these five samples developed coating failures at locations in direct contact with the fixture.

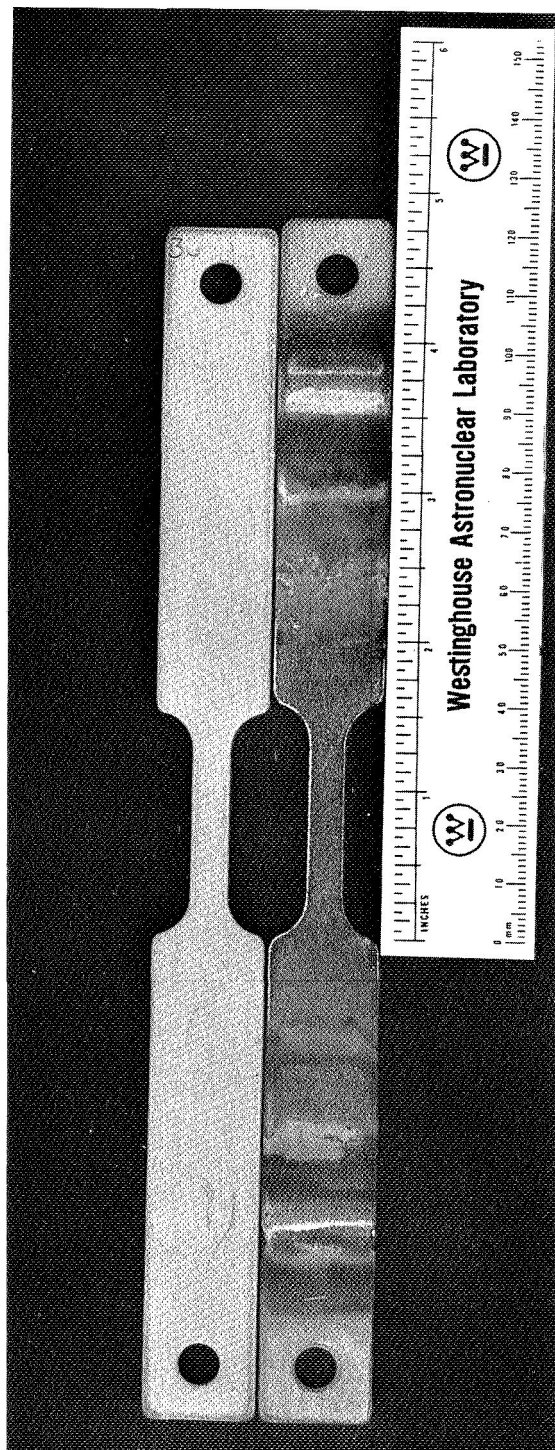
FIGURE 17 – Comparison of Creep Sample 26 with an As-Coated Sample

Creep data are presented in Table 12. The first test performed was on sample 26 at 8 ksi. This as-coated specimen was tested for 500 hours and displayed a 0.0130%/hr. creep rate throughout the entire period. Elongation of 7.0 percent was measured directly from the tested sample, corresponding closely with 6.8 percent, the value of the last creep strain measurement. A photograph of the tested sample is displayed in Figure 17 where comparison is made to an as-coated specimen.

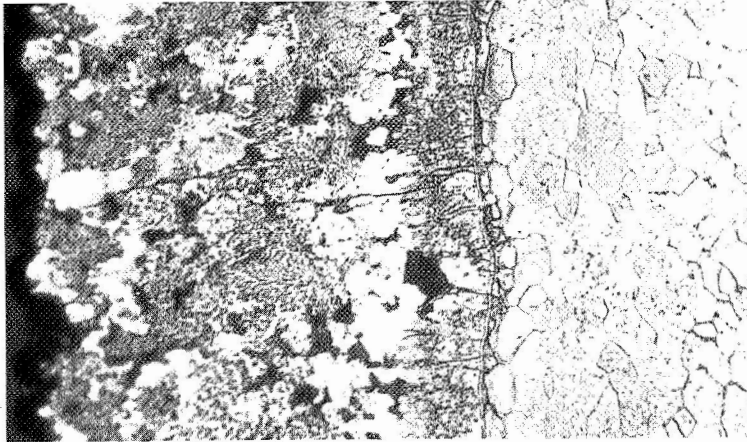
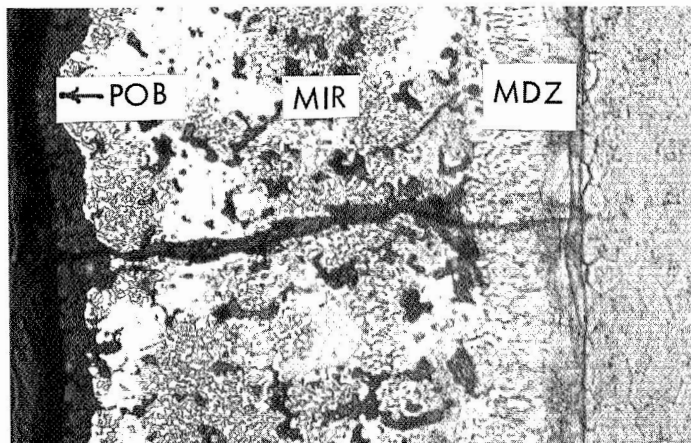
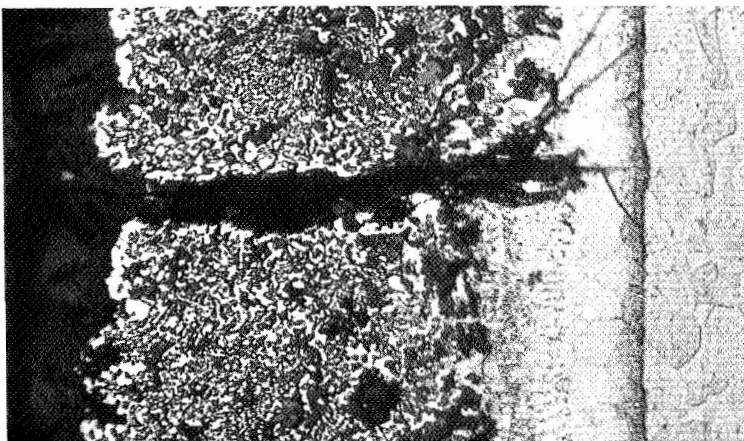
FIGURE 23 - Primary Oxide Barrier Formation at 2400°F (1589°K) Mag: 300X

A primary oxide surface barrier of TiO_2 particles in a SiO_2 matrix formed during oxidation of the study coating. Oxidation also occurred within fissures and pores traversing the coating.

Primary Barrier Development. Microstructures across the coating thickness on samples air exposed at 2400° F for 10 and 284 hours*, are shown in Figure 23. Included for comparison in the figure is the as-coated condition.

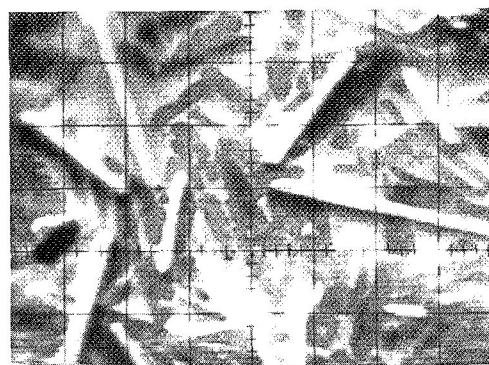
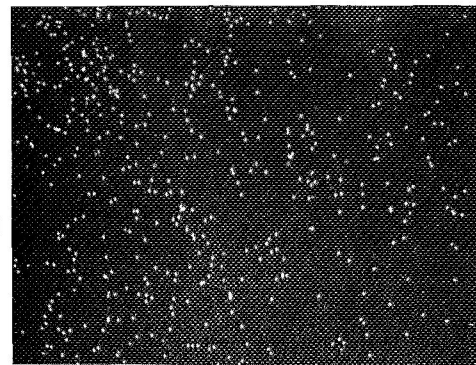
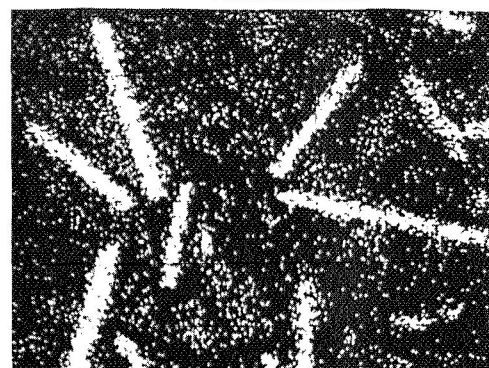
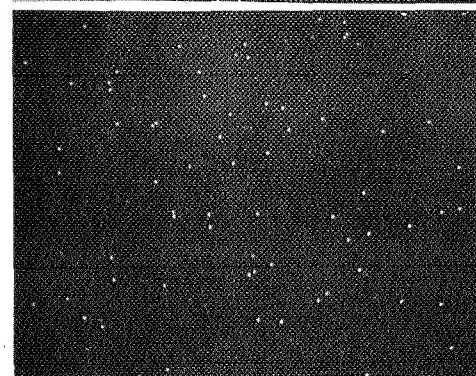
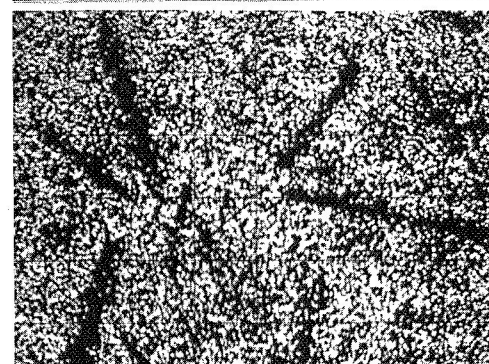
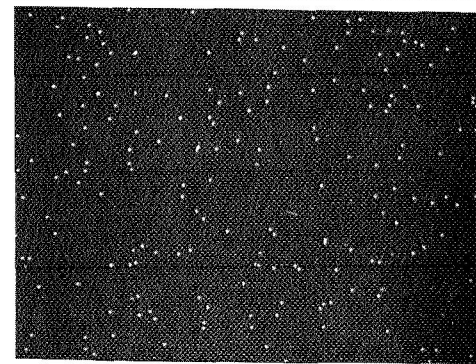
FIGURE 26 - Concentration of Elements at the Primary Oxide Surface Developed by
Oxidation at 2400°F. Bend Sample 17 Oxidized 134 Hrs/2400°F.
Mag: 500X

Electron microprobe analysis for the presence of major coating and substrate elements in the two phase surface structure, Figure 26*, revealed the particle phase to be titanium rich, and the matrix silicon rich. Other elements present in the as-applied coating, tungsten, vanadium and molybdenum, were not detected at the primary oxide surface. Similarly, tantalum and hafnium, elements common only to the substrate, did not migrate through the coating to its surface during exposure of the sample.

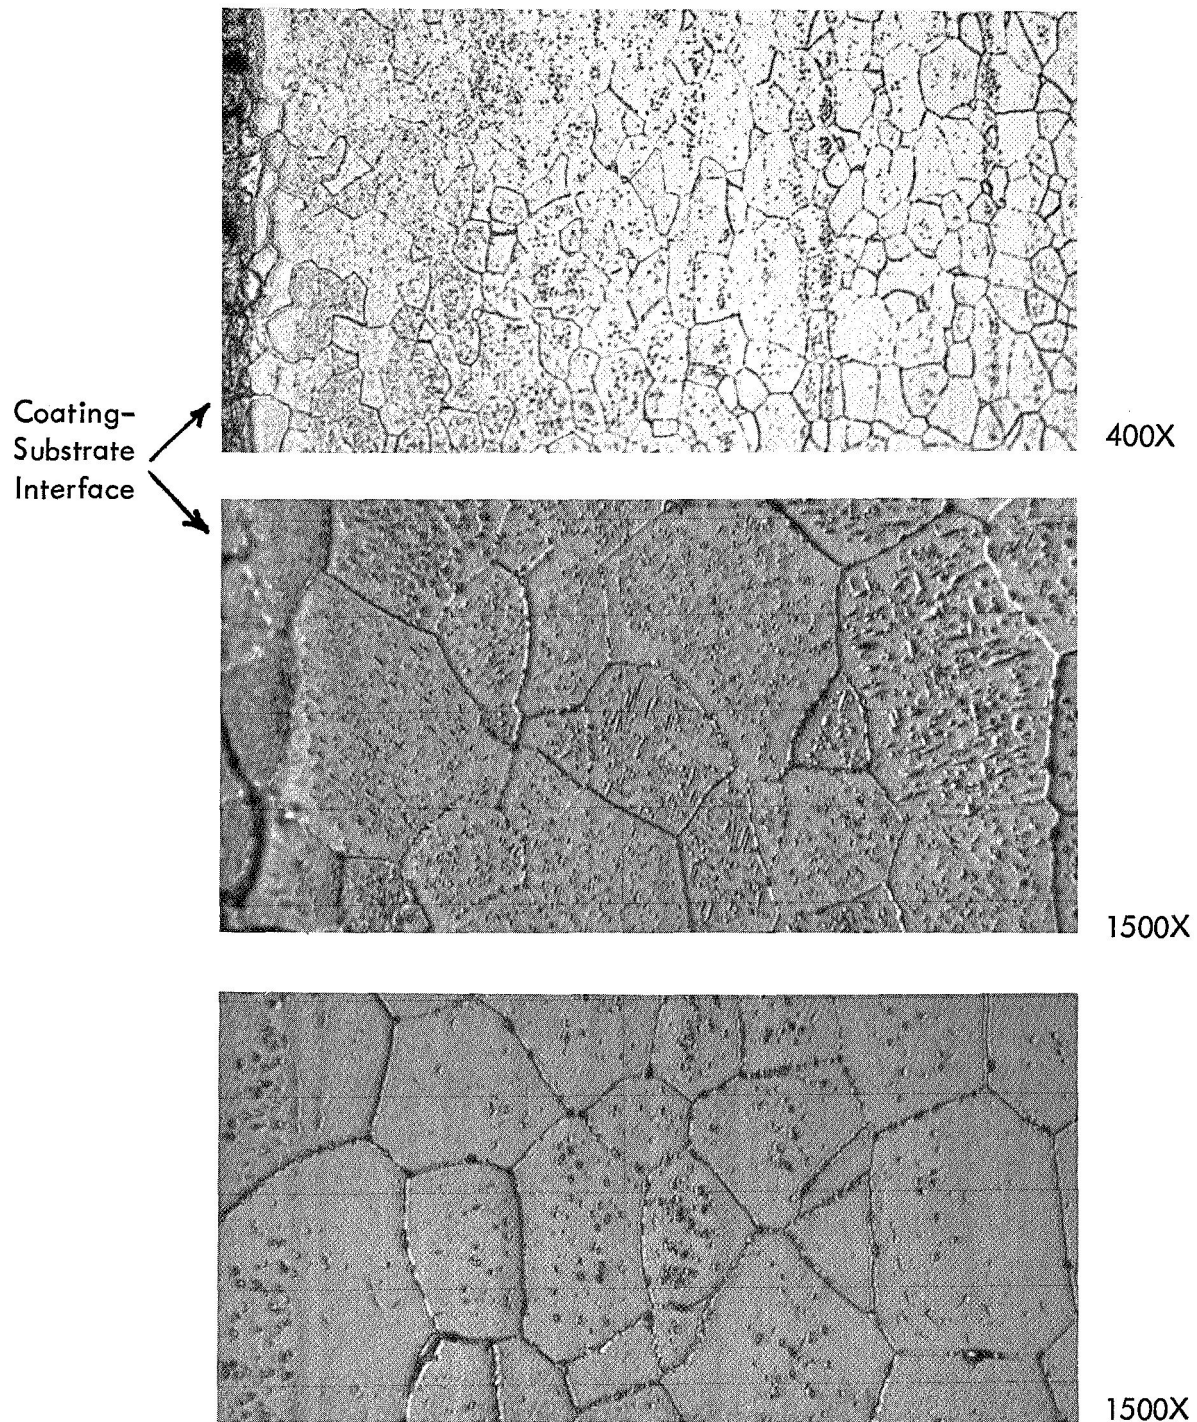
FIGURE 27 - Microstructure of The T-222 Alloy Substrate After Coating
Top & Middle: Structure into the Substrate from its Interface with the Coating
Bottom: Structure at Center Thickness of the Substrate

Substrate Structure Changes. Photomicrographs characterizing the structure of the T-222 substrate throughout its thickness are presented in Figures 27 through 30 for the as-coated condition, and the conditions developed by air exposure for 10, 284 and 437 hours at 2400° F. Photomicrographs representing the T-222 structure prior to coating are displayed in Figure 31 for comparison. Bend sample 12 and tensile sample 17 were used to represent the 10 and 284 hours-at-temperature conditions — Table 6. The 437 hour time-at-temperature condition was obtained from creep sample 27 — Table 12. It should be noted that time-at-temperature was accumulated on bend sample 12 and tensile sample 17 in the cyclic manner used for oxidation testing, whereas exposure of creep sample 27 occurred under stress and was continuous.
